ウクライナ歴史的木造教会の保存におけるリビングヘリテージアプローチ

Living Heritage Approach to the Conservation of Historical Wooden Churches in Ukraine

BOGDANOVA Anna

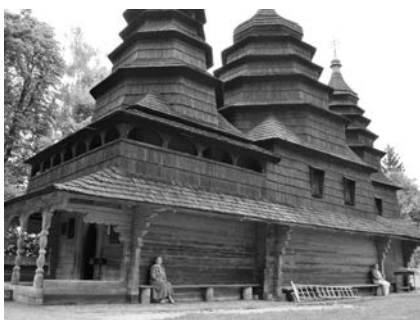
At the heart of this study – historical wooden churches, unique representatives of the Orthodox ecclesiastic architecture built in log-house construction technique (fig.1), preserved in big numbers across the territory of Ukraine (fig.2).

Figure 1 Wooden Church of St. Mykola in Lviv open-air museum of architecture

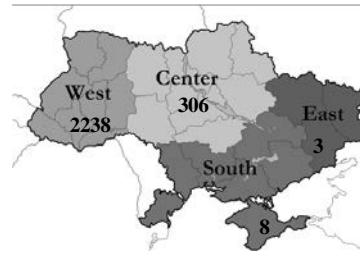
Figure 2 Numbers of preserved historical wooden churches in different regions of Ukraine

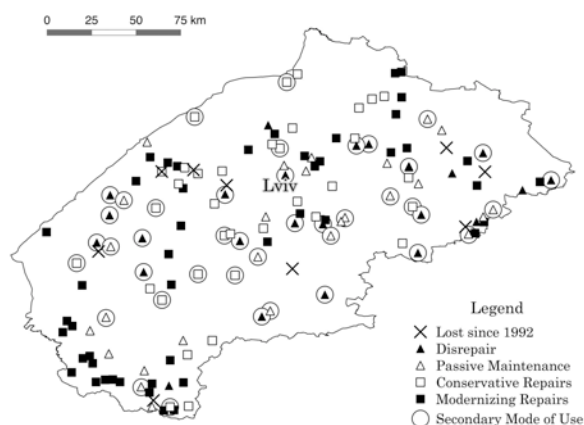
Figure 3. Observed patterns of maintenance and use of sampled wooden churches located on the map of Lviv Oblast'

Figure 3 shows the observed patterns of maintenance and use, located on the map of Lviv Oblast, including the designated wooden churches that were lost during the years of Independent Ukraine. Certain tendencies could be picked up from the mapping outcome. For instance, the peculiarity of the South-West region of Lviv Oblast, where most of the wooden churches are modernized and used in primary function. The absence of modernizing repairs and the prevalence of disrepair in secondarily used wooden churches confirms the hypothesis of the major role of church function in maintenance practices.

Matkiv village is located in the mountainous South-West region. In this area, wood is still a major material for construction, and traditional building techniques are commonly used. Every village has a functioning wooden church. This, and the remoteness of the region from the administrative centers explain the prevalence of the modernizing maintenance practices, displayed in Figure 3.

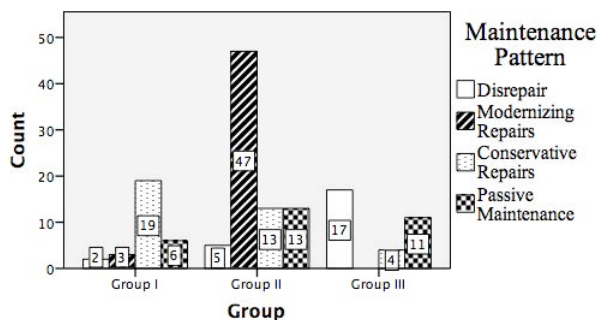
Group III – churches with low public control and low user value (secondarily used churches in rural areas). They are more likely to decay, but highly unlikely to be modernized (graph 1).

Graph 1 Distribution of the observed maintenance patterns between the groups

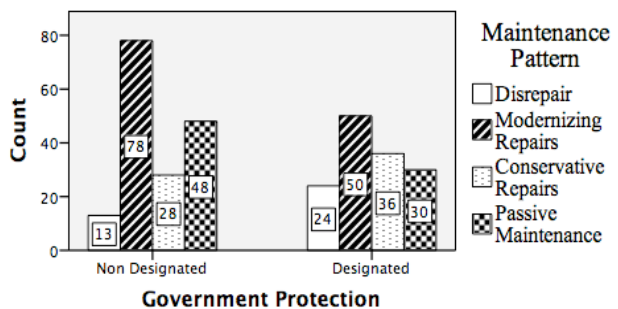
Graph 2 Distribution of the observed maintenance patterns between designated and non-designated churches

insignificant difference was observed in the patterns of modernizing and conservative repairs, which proved little to no effect of the current heritage protection policies. Moreover, designated wooden churches displayed higher rates of abandonment and more severe signs of decay, which can be interpreted as the discouraging effect of heritage policies on the community-based custodianship (graph 2).

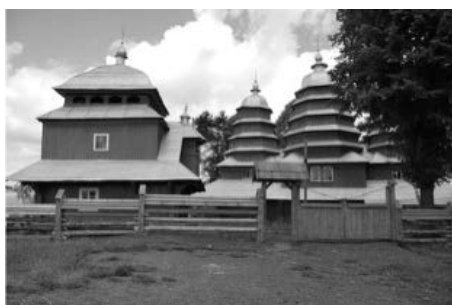
Figure 4 Wooden Church of St. Dmytro (1838), Matkiv village (July, 2015)

The 19th century Church of St. Dmytro (fig. 4) was recently inscribed on the World Heritage list. It stands out among the neighbors being the least modified and decorated. Even before it became the World Heritage site, the priest of the parish exercised his authority to prevent many attempts of modernizing repairs.

The Nomination file sets plans to restore the original appearance of the church – clad roofs with wooden shingles and uncover the logs of the

first tier. However, the local community opposes to these changes, valuing the present look of the church, - with sheet metal roofs and bright interior oil paintings. The joint Steering Committee of the site, featuring community representatives, is working to find a balance of all stakeholders' interests.

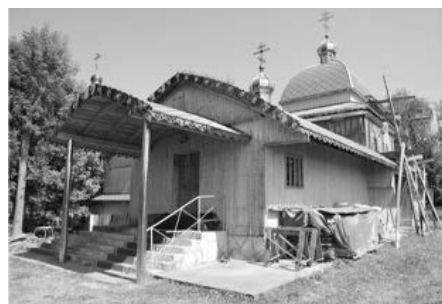
Figure 5 Wooden Church of Assumption of Blessed Virgin Mary (1738), Matkiv village (August, 2015)

Vidniv case, representative of Group II, depicts a primary used 18th century heritage wooden church currently undergoing modernizing repairs (fig. 5).

In early 2000s, walls of the church were covered with low quality wooden panels, roofs - with modern titanium nitride (TiN) cladding, igniting an outrage in heritage activists' circles. In 2015 – another repair is in progress. Local craftsmen are replacing wooden panels that already decayed and damaged underlying log structure.

Interviews with local residents and craftsmen showed that community is interested in maintaining their church in good state but not at the costs that are required according to the present heritage legislation. Doing the repairs in secret they often lack valuable consultation of heritage specialists.

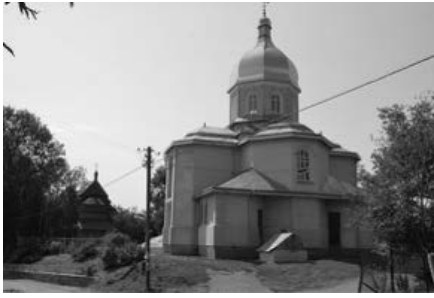
Figure 6 Wooden Church of Assumption of Blessed Virgin Mary (1604) and the new church construction Klits'ko village (August,

bigger and more prosperous Orthodox community is currently building a new stone church at the same location (fig. 6).

The scientific restoration took place in 2007, led by a famous civil activist, village expat. Sadly, in 2008 the church was damaged by fire, and had not been repaired since.

It is quite possible that the one-time conservative intervention has actually left the church in more vulnerable condition, as the small and aging Greek Catholic community of the village has no means of sustaining the high-maintenance wooden cladding of the church. Also, this case demonstrates how the construction of the new church weakens maintenance of the heritage church in a small community.

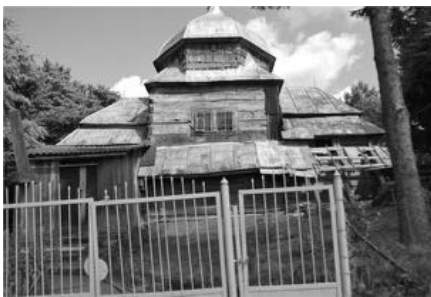
Figure 7 Wooden Church of the Blessed Virgin Mary (1724), Loni village (July, 2015)

Loni case, representative of Group III, describes the community-based efforts to restore the 18th century wooden church that have fallen into disuse and decayed and the repairs are currently in progress (fig. 7).

communications. It is a place where only old people leave and in winter even they prefer to stay with their children in cities. Greek Catholic Community of the village uses a new stone church built in 1994. The old wooden church has fallen into decay, but villagers still come to pray there privately using a church's porch for the altar.

Evidently, the church has big importance for the local community as a place of religious wonderwork, memorable historical events, personal nostalgia and even symbolic self-identification. Therefore, in 2010, the expats of the village in Lviv city and abroad initiated a fundraising campaign to rescue the church from destruction and to restore its historical appearance. When community used private funds, there was a problem with contractors who did not follow the restoration project and worsened the state of the church. After that, regional government allocated budget money and organized proper surveillance.
